U.S. ENVIRONMENTAL PROTECTION AGENCY
POLLUTION/SITUATION REPORT
2015 Gold King Mine Release SITREP

Subject: SITREP #5
Gold King Mine Release

San Juan County, Colorado
Latitude: 37.8945 Longitude: -107.6384

From: Colorado Unified Command Situation Unit
Date: 08/13/2015
Reporting Period: 08/12/15 through 08/12/15
Website: epa.gov/goldkingmine

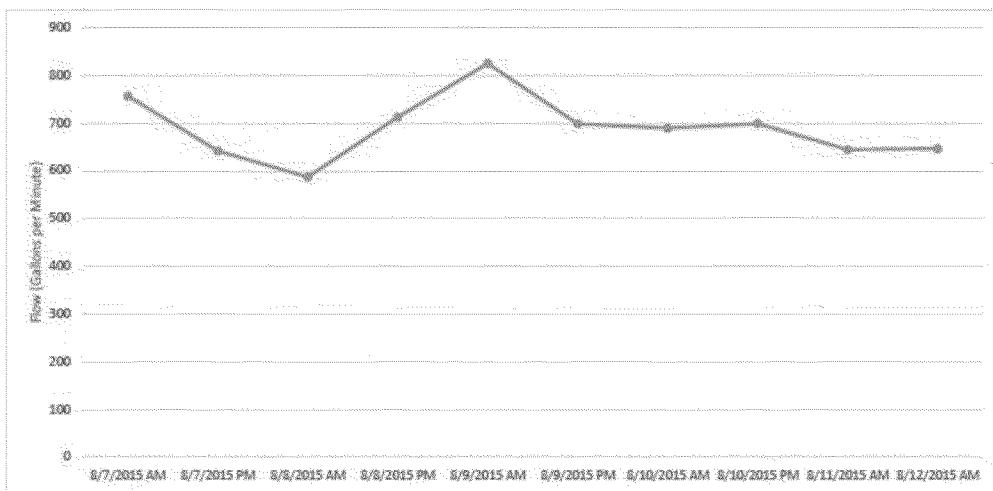
The EPA continues to operate four treatment and sedimentation ponds at the mine site which are treating water by lowering acidity levels and removing dissolved metals. Flow from the mine through the morning of 8/12/2015 is shown in the following chart. **As of 11 am on 8/13/2015, there was no available updated water discharge data available.**
